**GOEDEHOOP  
COLLIERIES  
BLOCK 7  
PROJECT**

South Africa

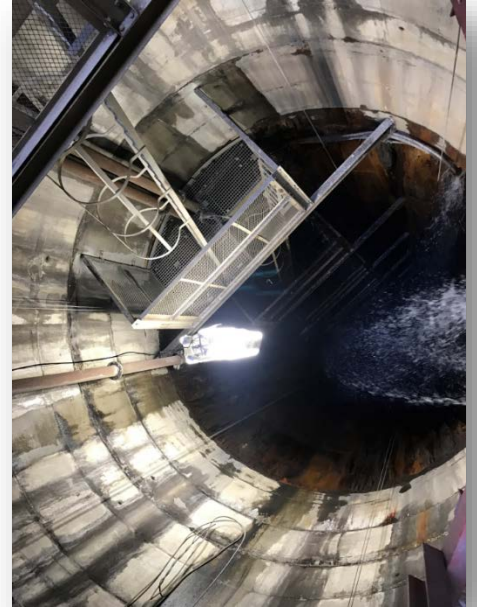
*View from the top of the shaft during the site inspection. The extreme water ingress points are evident all the way down the ventilation shaft. The base of the ventilation shaft was filled with water for 35 years.*

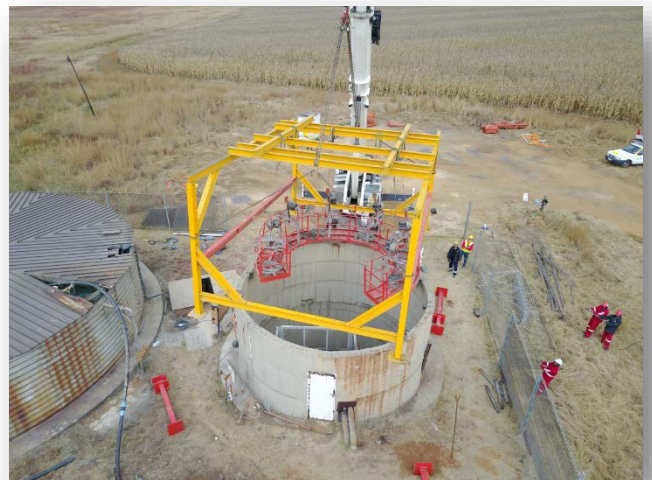
*Access to the shaft was a huge safety and logistical concern. The access specialists were able to supply a custom built cradle to lower workers into the shaft. This cradle was anchored to the sides of the shaft to ensure that there was no movement during the high pressure cleaning and sandblasting.*

The very first obstacle to overcome was that of access down the 7 m diameter shaft riddled with leaks. After numerous discussions and on-site tests, the appointed access company, devised a cradle system to safely lower workers into the shaft. The cradle also needed to be stabilized against the sides of the shaft to reduce movement for the work at hand.

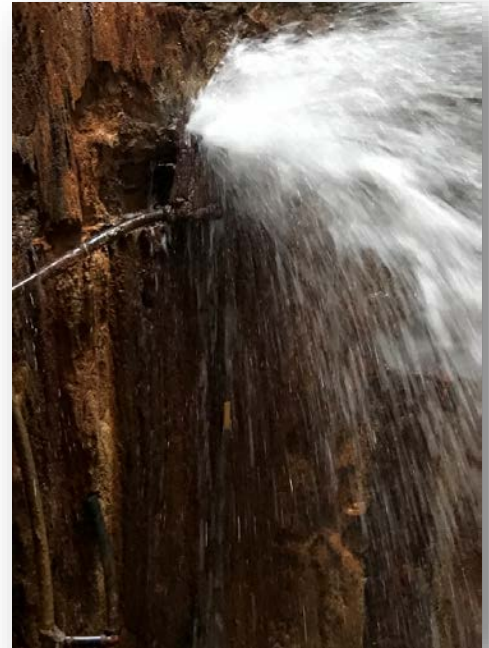
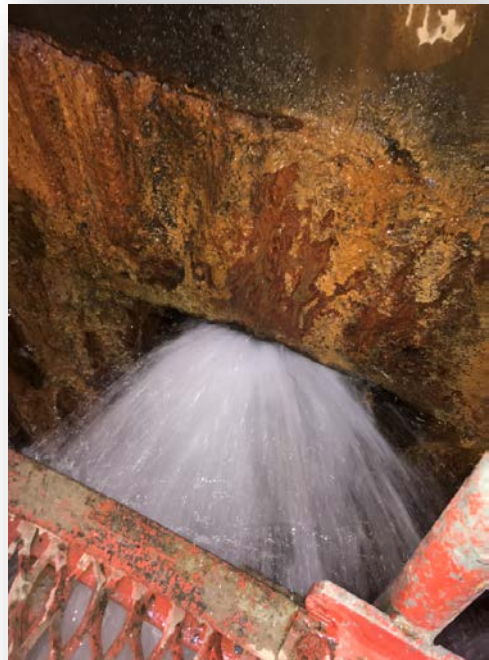
The ingress pressure of the water was immense, shooting water torrents approximately 300 mm wide across the 7m diameter shaft.

There were numerous water ingress points along the full depth of the shaft, with the primary water ingress area, located between 19 and 25 m below ground level.

*Major water penetration points were blasting masses of water 300 mm wide right across the 7 m diameter of the shaft. The extreme pressure of the water was causing damage to the structure of the shaft as well as making the repair a very dangerous project*

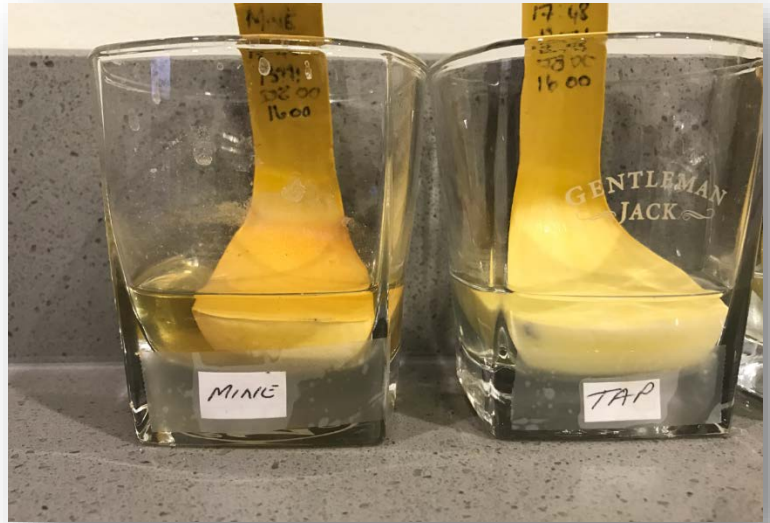
*Swelling waterstop being tested with shaft waters VS tap water.*

With information gathered by visuals, a swelling waterstop had to be introduced to the positive side to reduce the water flow to a manageable condition.

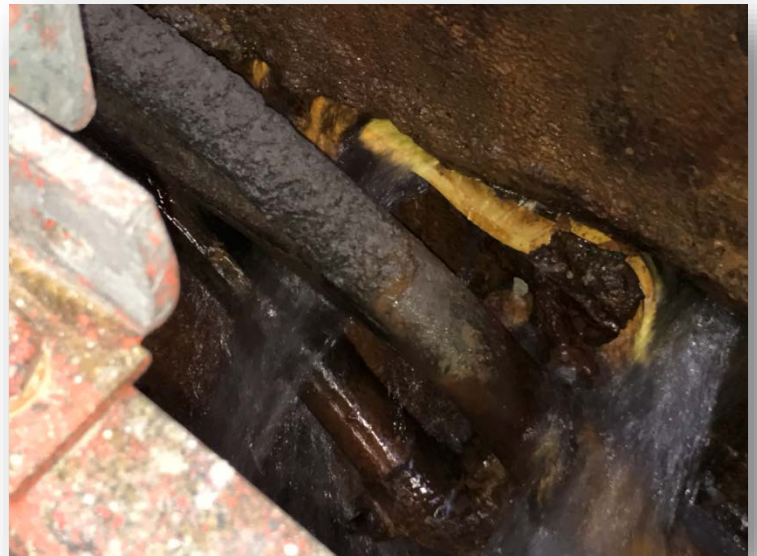
*The waterproofing specialists also tested the swelling waterstop on the ingress points to ensure that the waterstop would swell to its maximum capacity to alleviate water pressure to continue with the crystalline leak repair system..*

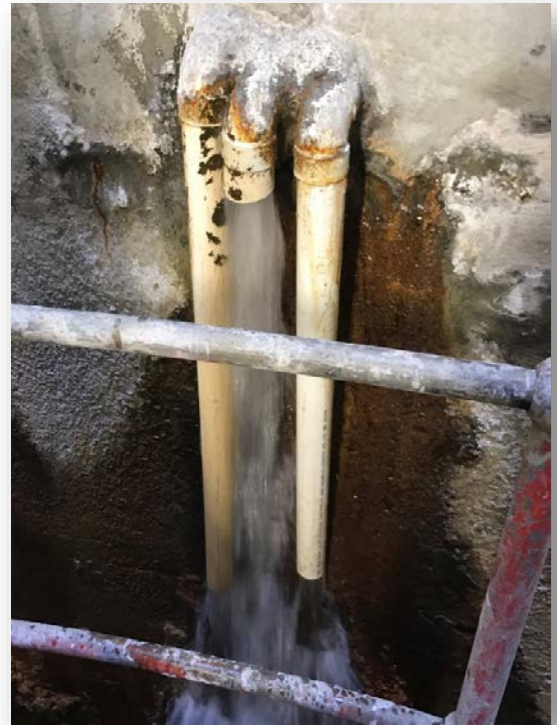
*Using a rapid-setting hydraulic cement and a swelling waterstop, the waterproofing specialists were able to successfully contain the flow of water to a single access point, thus making the water more manageable.*

Running water was stopping by the use of a rapid-setting hydraulic cement and a swelling waterstop.

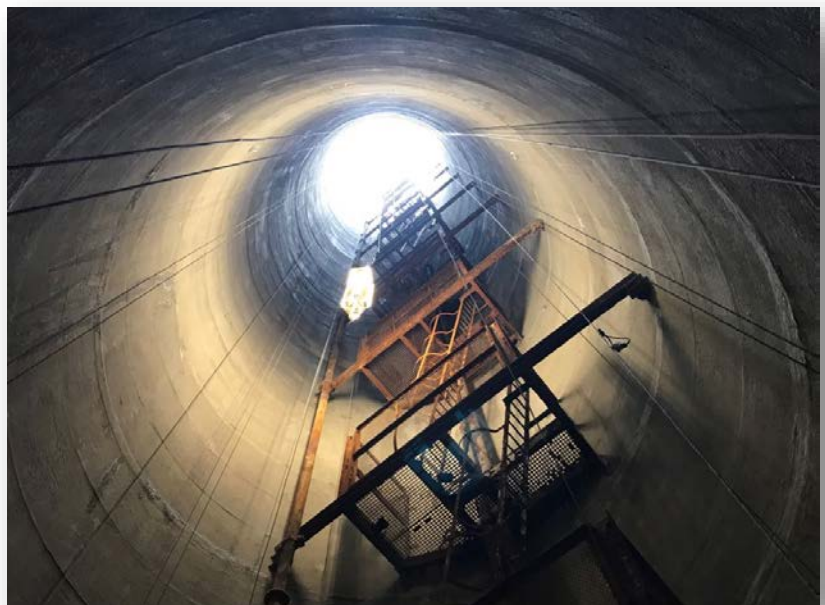
*View from the bottom of the shaft once the project was complete*

The overall result is a safe, dry and useable structure.

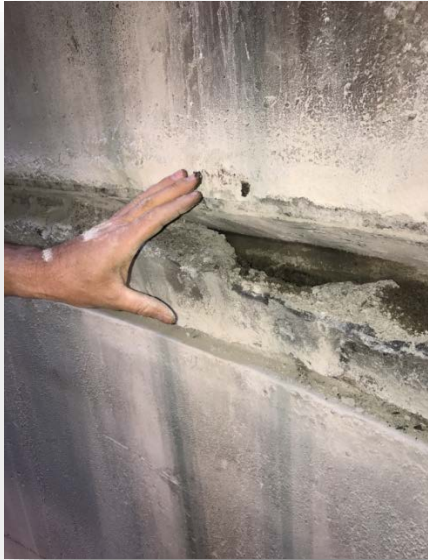
Image A:

*After the water was fully contained using a rapid-setting hydraulic cement and a swelling waterstop, the surface area was correctly prepared and applied with a crystalline repair grout (image A) and crystalline surface applied waterproofing (image B).*

Chased cold joints were filled with a repair grout (specially mixed dry-mix).

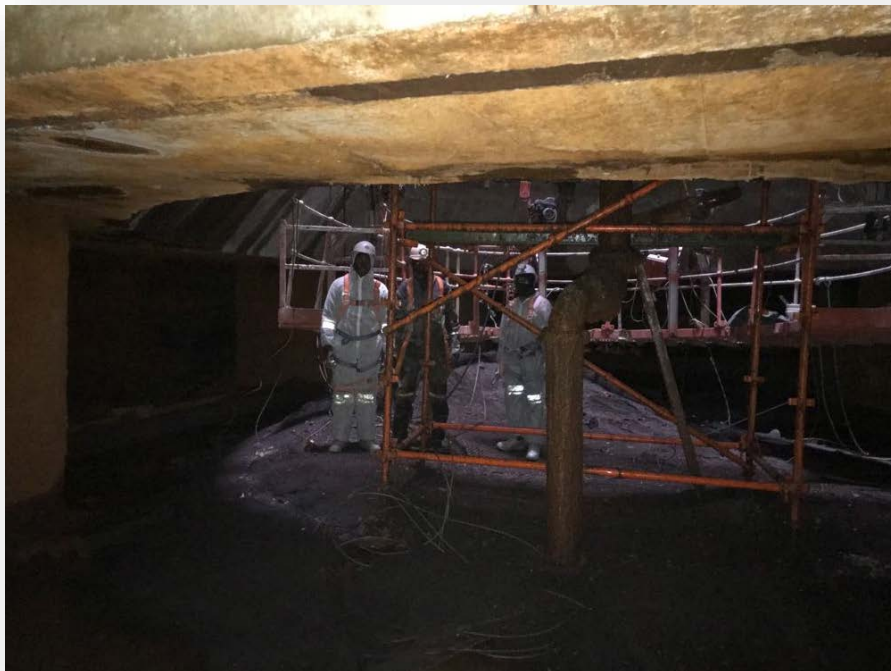
*The base of the shaft had not been seen or dry for over 35 years. This was the first time that workers were able to stand at the base of the shaft.*
